Field Notes Nov. 15, 2000
Chenier Plain Sediment Burial Pipe Measurements

Chris Moeller, Mat Gunshor, Oscar Huh
Dale Winch, airboat pilot
University of Wisconsin – Madison
Louisiana State University

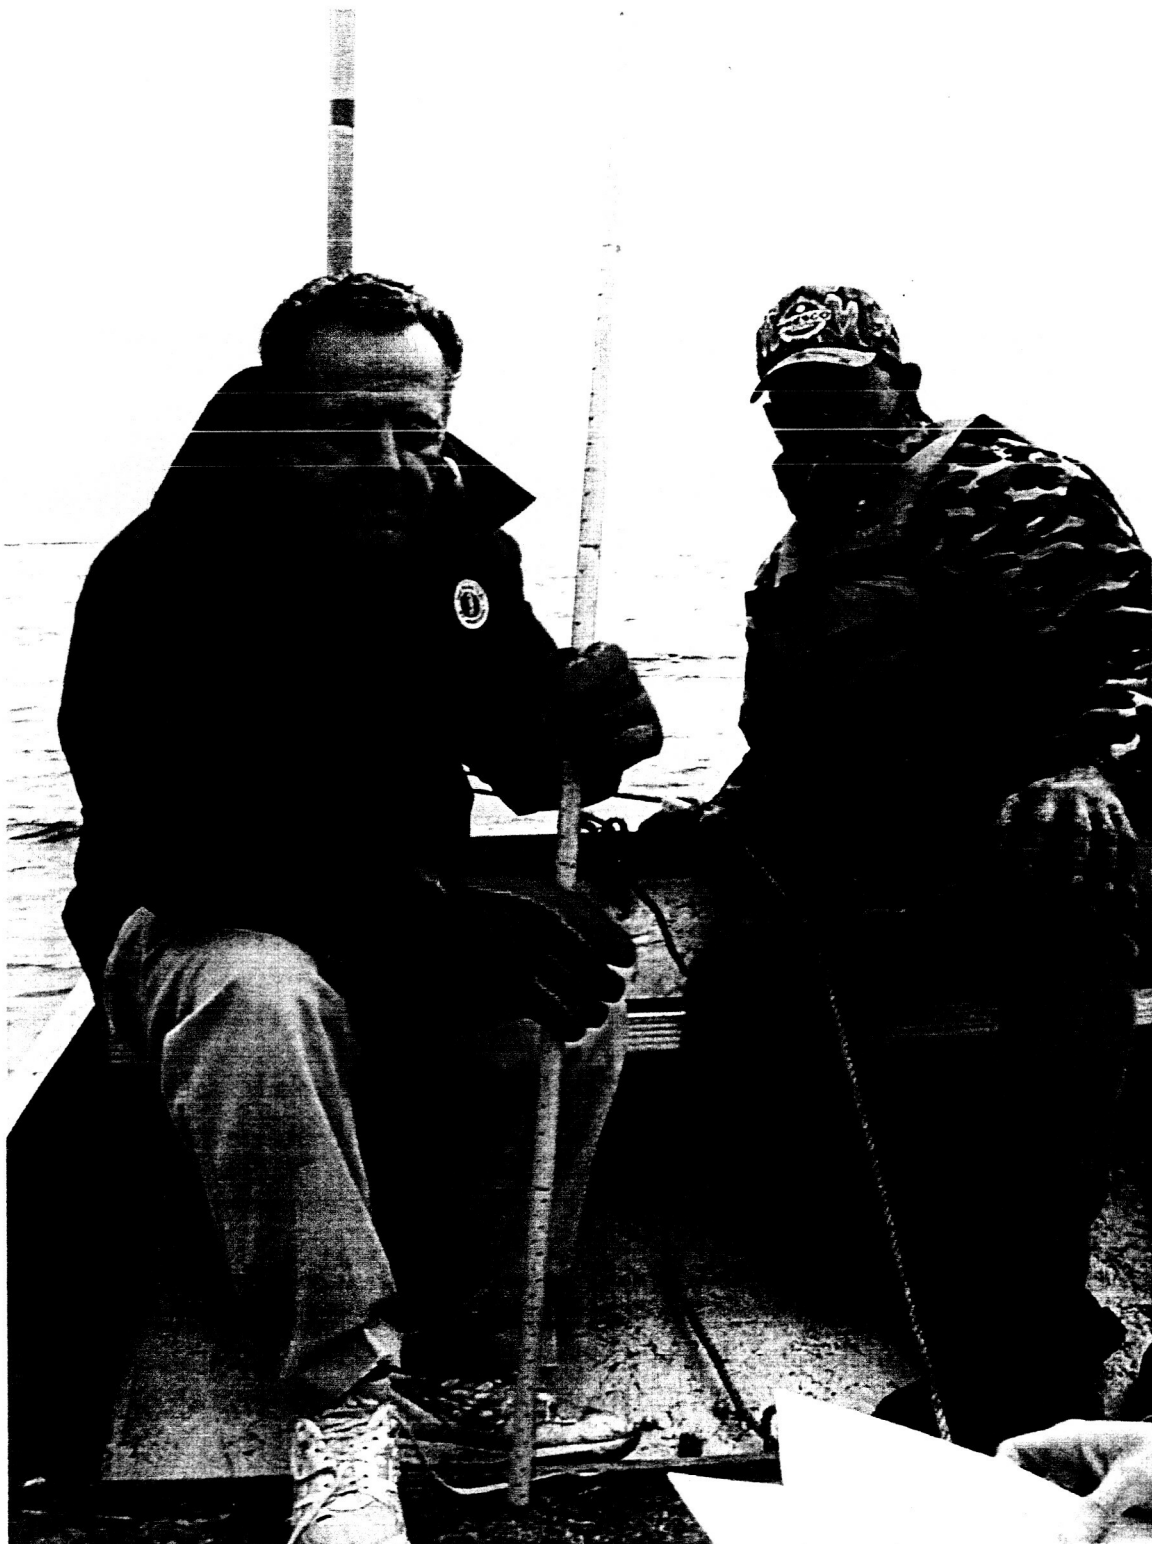
1. Oscar displaying our make-shift measuring stick. (Dscn0004.jpg)

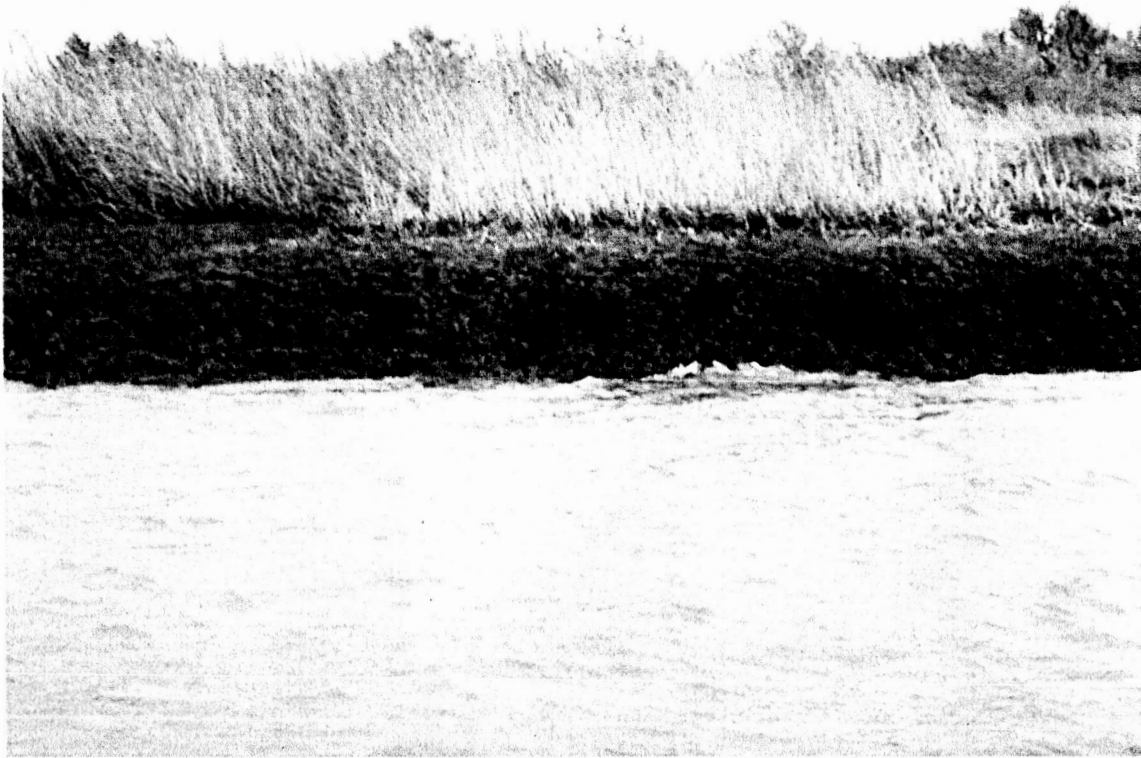
2. Firm mud ridge at Western Erosion Site. Note pockmarked surface, possible remnant pathways of vegetation root systems. Erosional forces seem to be cutting the beach and stranding the vegetation. (Dscn0005.jpg)

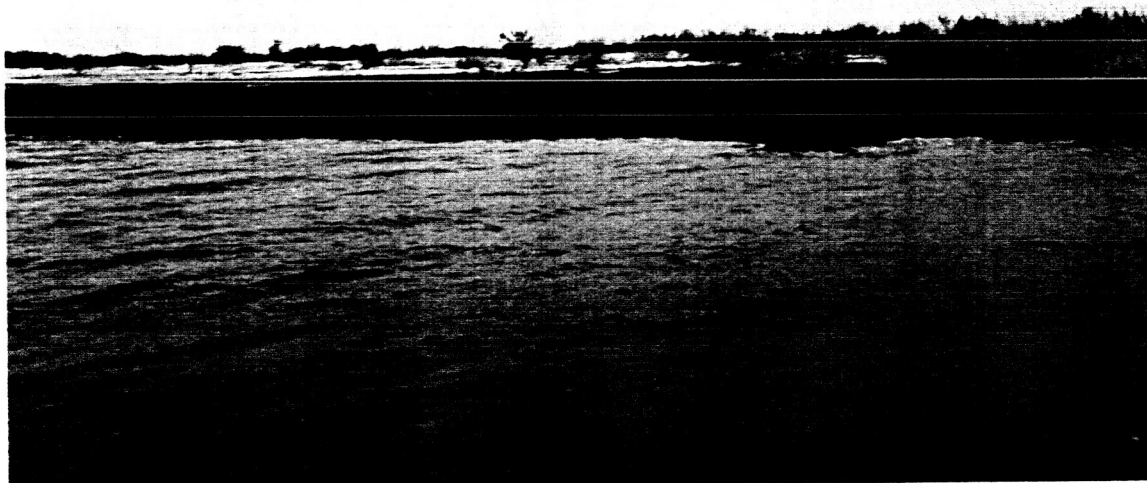
3. Sand Ridge beyond pock-marked mud shoreline at WES. Sediment burial pipe positions suggest that the beach ridge has eroded back since 1994. (Dscn0006.jpg)

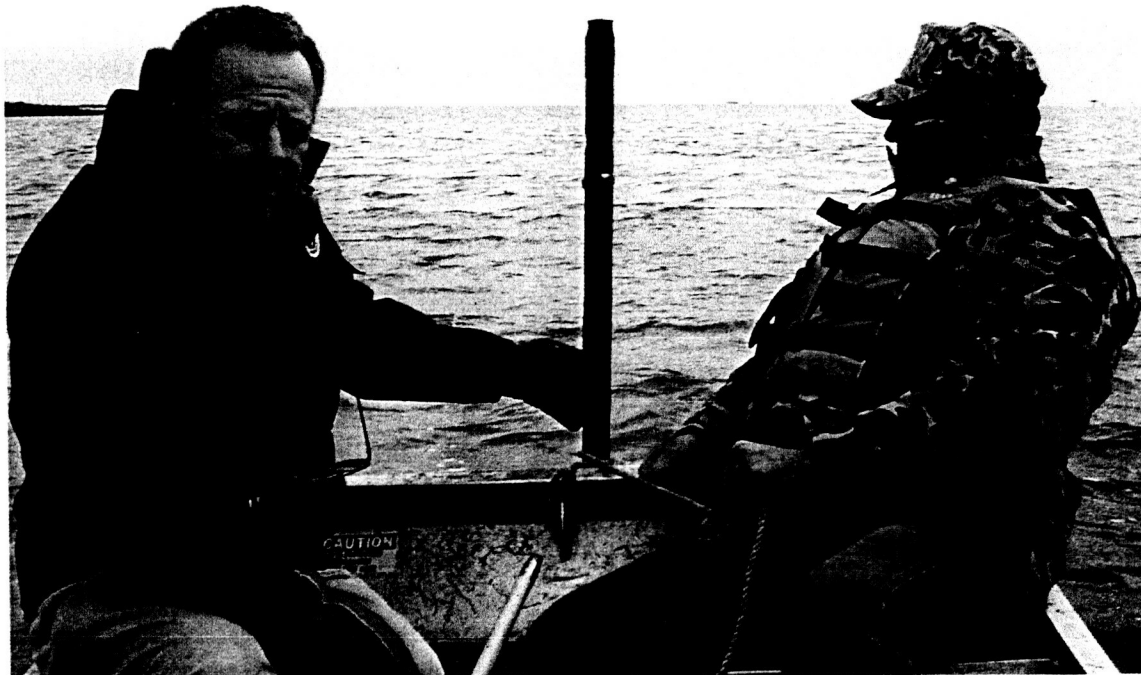
Description: Pipe standing in about 2.5' of water. The subaqueous bottom here was described as firm and wet. An outer clamp on this pipe has broken loose from rust, exposing an inner clamp that is itself severely rusted (as well as the pipe).

4. Pipe at WES #2. Note broken outer clamp hanging on pipe and exposing severely rusted inner clamp about 3 inches above. (Dscn0007.jpg)

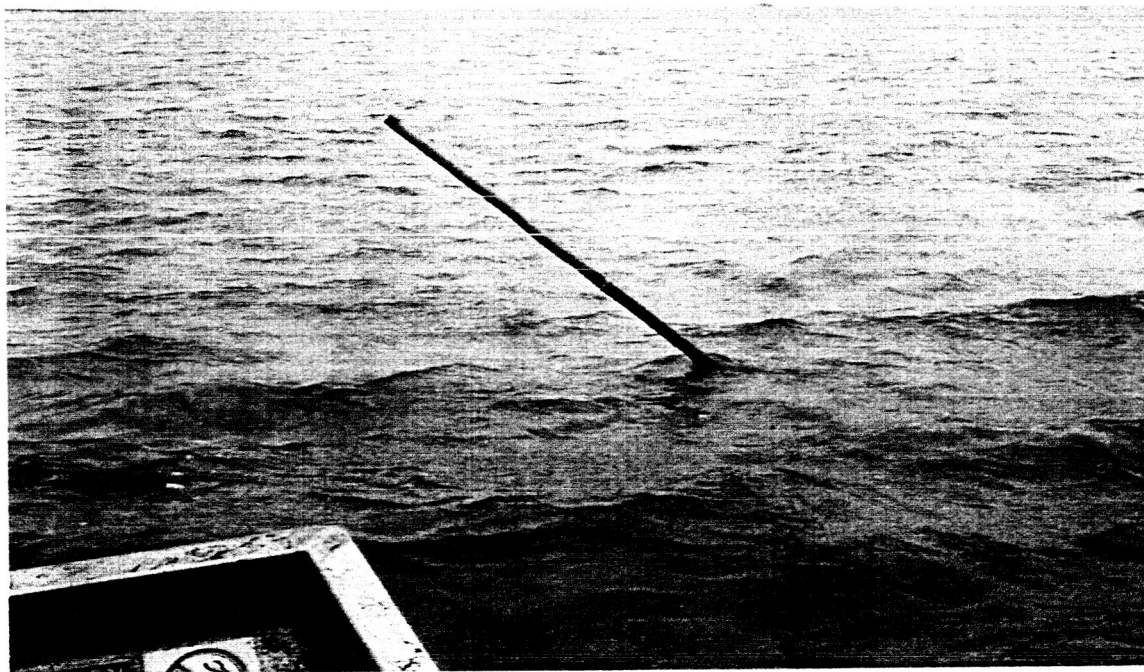
Description: This pipe is bent at about a 45-degree angle (was not bent in Sept 1997). Due to this fact we were unable to make a meaningful measurement from the clamp.

5. Bent pipe at WES #1 some 50 meters or more offshore. This pipe was vertical in Sept 1997. A measurement from the surface of sedimentation to the approximate water level at the pipe was recorded. Note light seas. (Dscn0008.jpg)

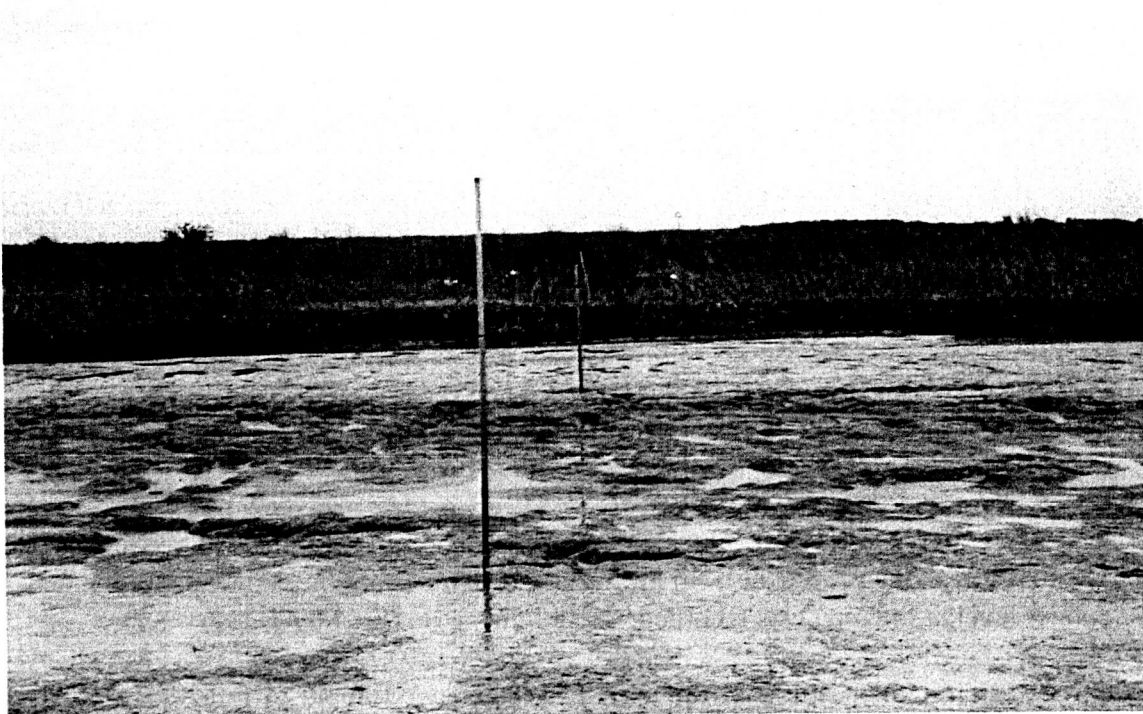
6. Looking North from DCS#1. DCS#2, #3, & #4 clearly visible in background.
(Dscn0010.jpg)

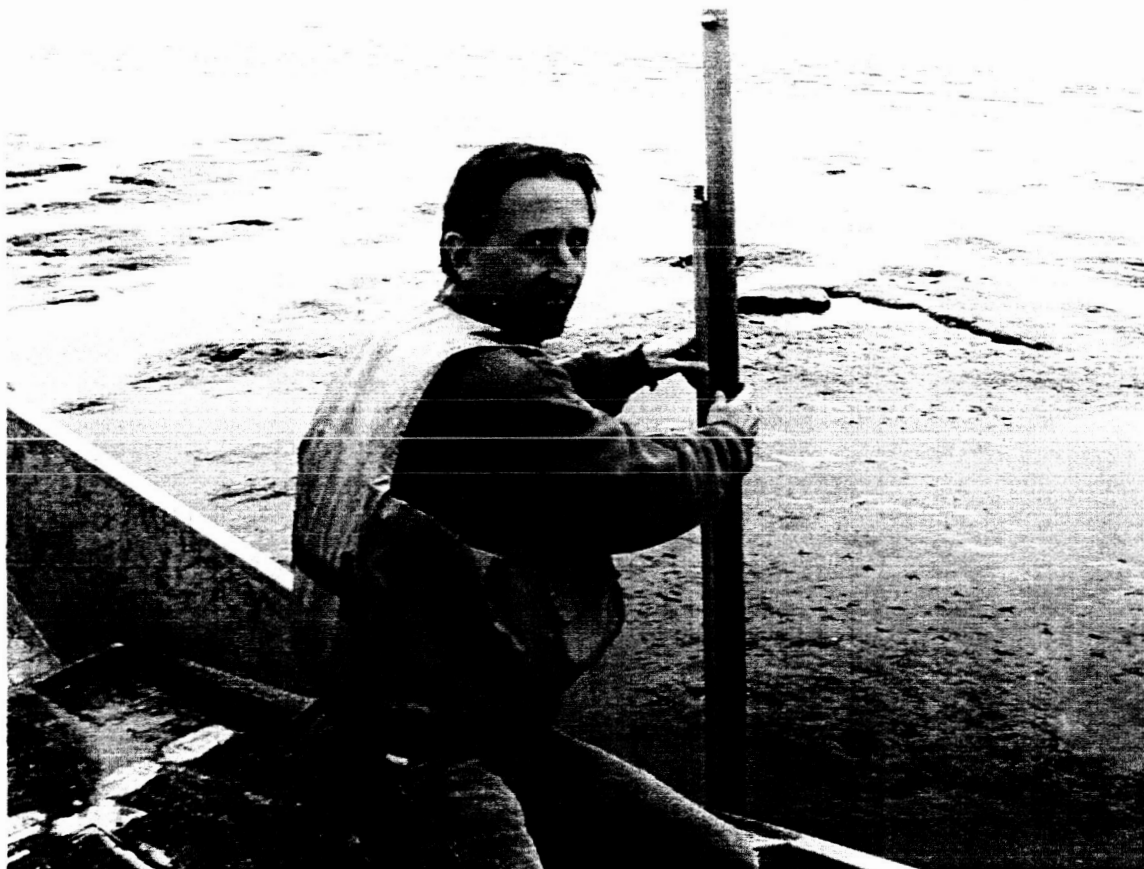
7. Chris measuring at DCS#1. The broomstick is sitting on the mud surface at the base of the pipe and the total distance to the clamp on the pipe (visible at the very top of picture) is being measured. Note puddling of surface water. The area immediately at the base of the pipes tended to be a bowl shaped depression, often several inches deep. Water level appeared to be quite low, and was observed rising later in the day. (Dscn0138.jpg)

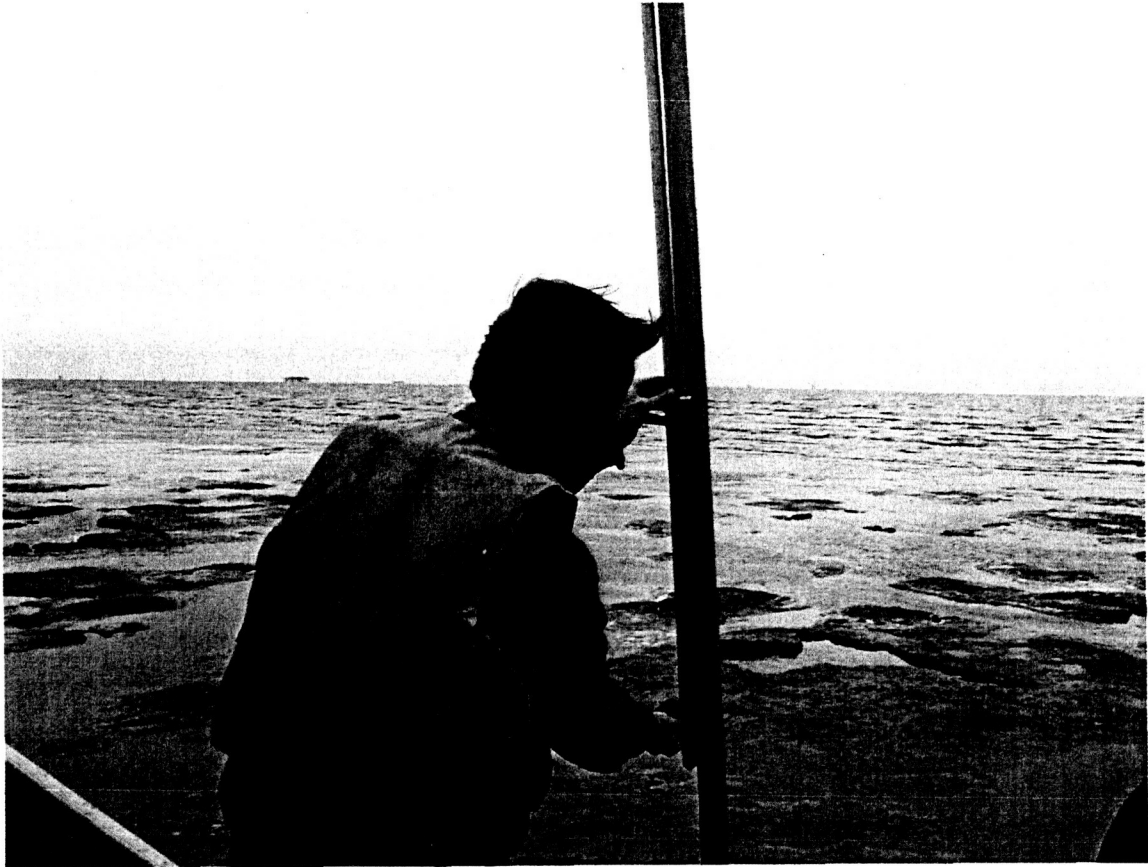
8. Chris completing the measurement to the clamp on DCS#1. The total distance in feet and inches from the surface of sedimentation to the clamp was recorded by Mat. The measuring process was generally completed within 1 minute. Error bars for this measurement procedure are estimated to be about $\pm 1/2$ to 1 inch. For some pipes, the distance from the upper clamp to the top of the pipe was also measured and recorded to complete a documentation process begun with the Sept 1997 field trip. (Dscn0139.jpg)

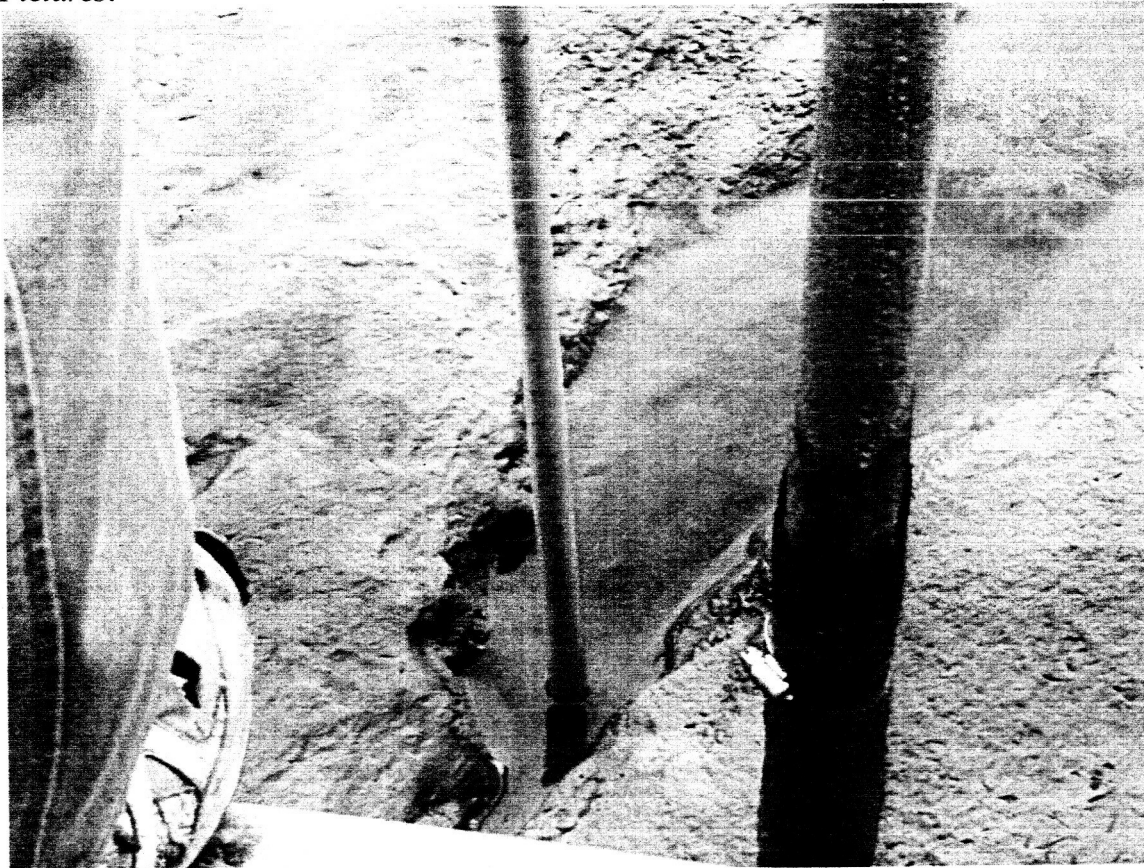
9. One of many shore normal rills, this one about 6" deep. This is pipe DCS#3.
(Dscn0140.jpg)

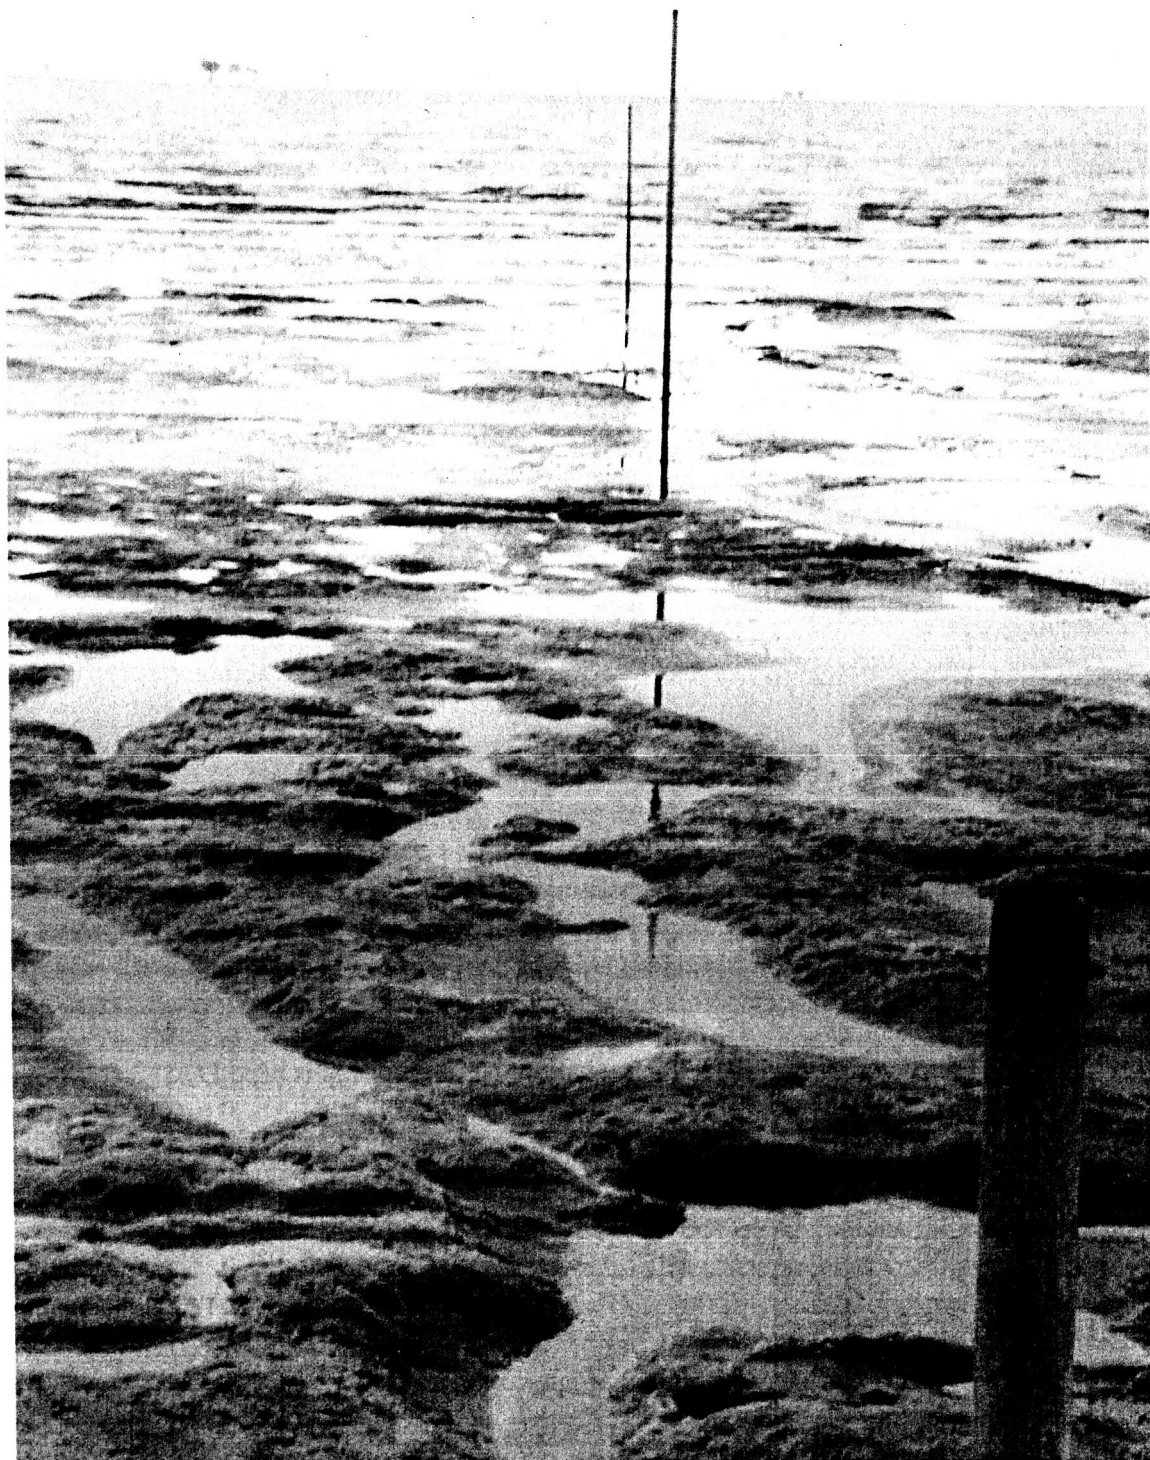
10. Facing seaward from DCS#3, DCS#2 and DCS#1 visible in the background, as well as several oil platforms. Significant puddling at DeWitt Canal site is evident. Oil platforms in background. (Dscn0141.jpg)

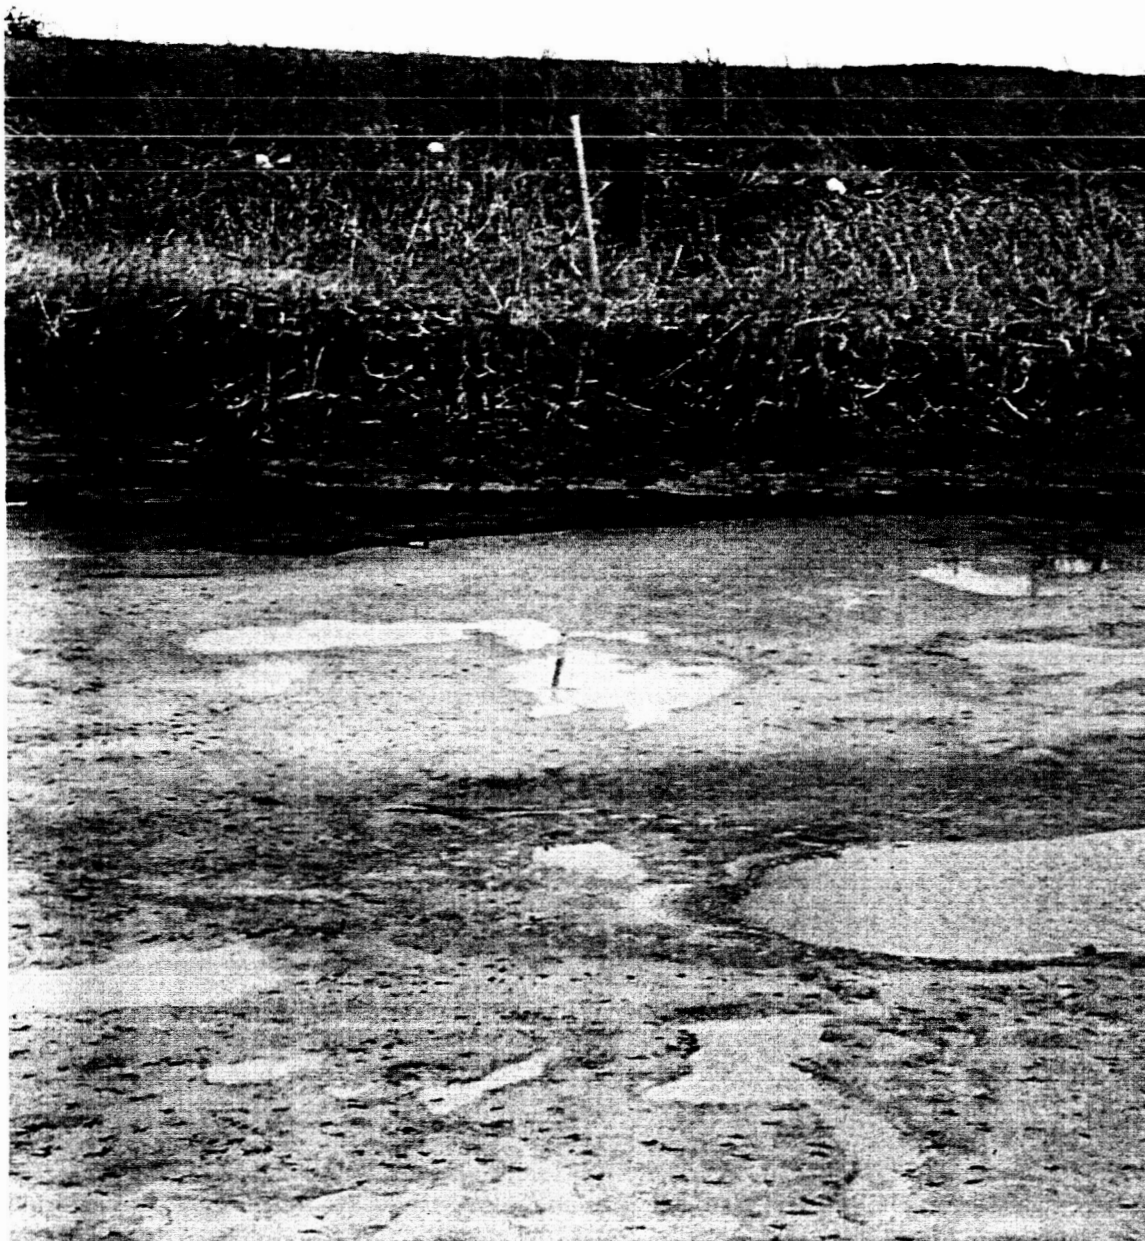
11. Facing shoreward from DCS#3, DCS#4 visible above escarpment just north (2 meters) of the edge of vegetation which reaches to the escarpment. A fifth pipe (DCS#5) is barely evident in the photo just at the edge of the taller vegetation in the background. The line between DCS#4 and DCS#5 is a former fence line. The

vegetation on the escarpment was severely matted for about 20 meters, suggesting overwash during a high water event. (Dscn0142.jpg)

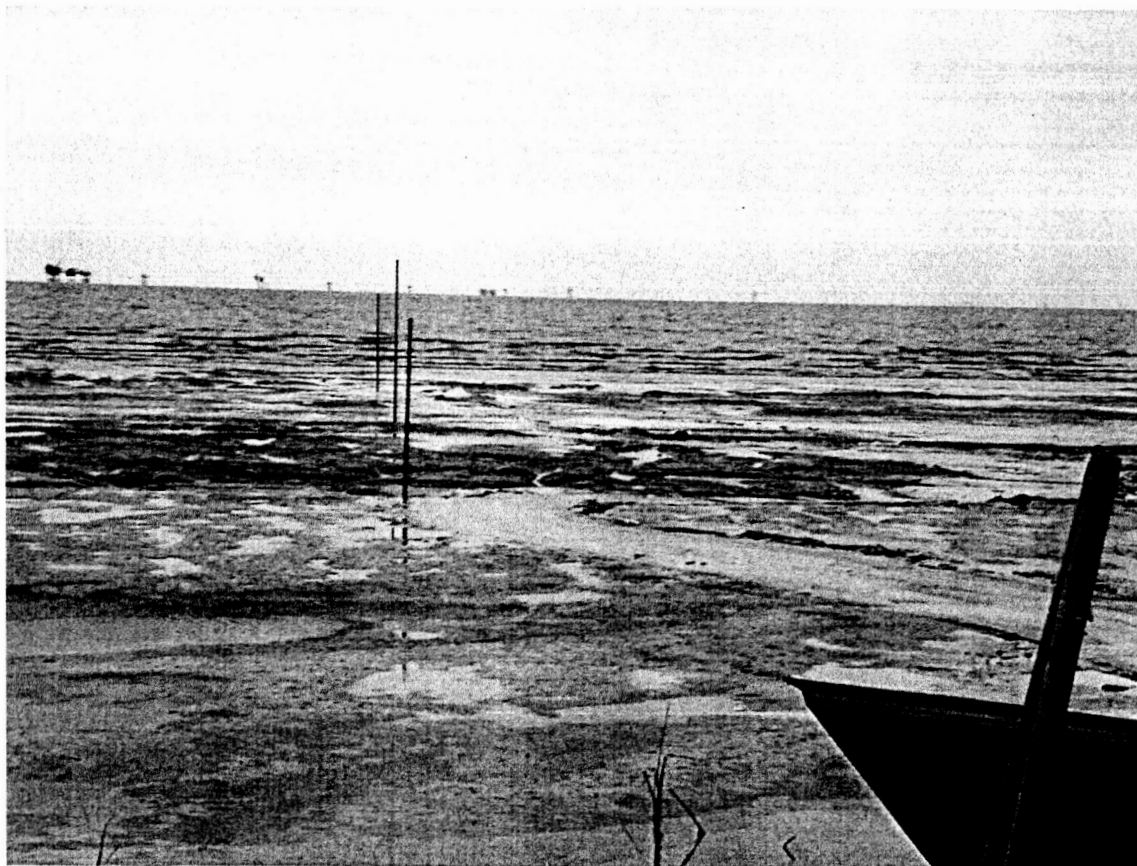
12. Seaward from DCS#4. DCS#1-3 are resting in exposed fluid mud. The exposed mud flat (water edge to escarpment) was estimated at about 100m at this time, based in part on an assumption that the sediment pipes were placed at 30m spacing. (Dscn0143.jpg)

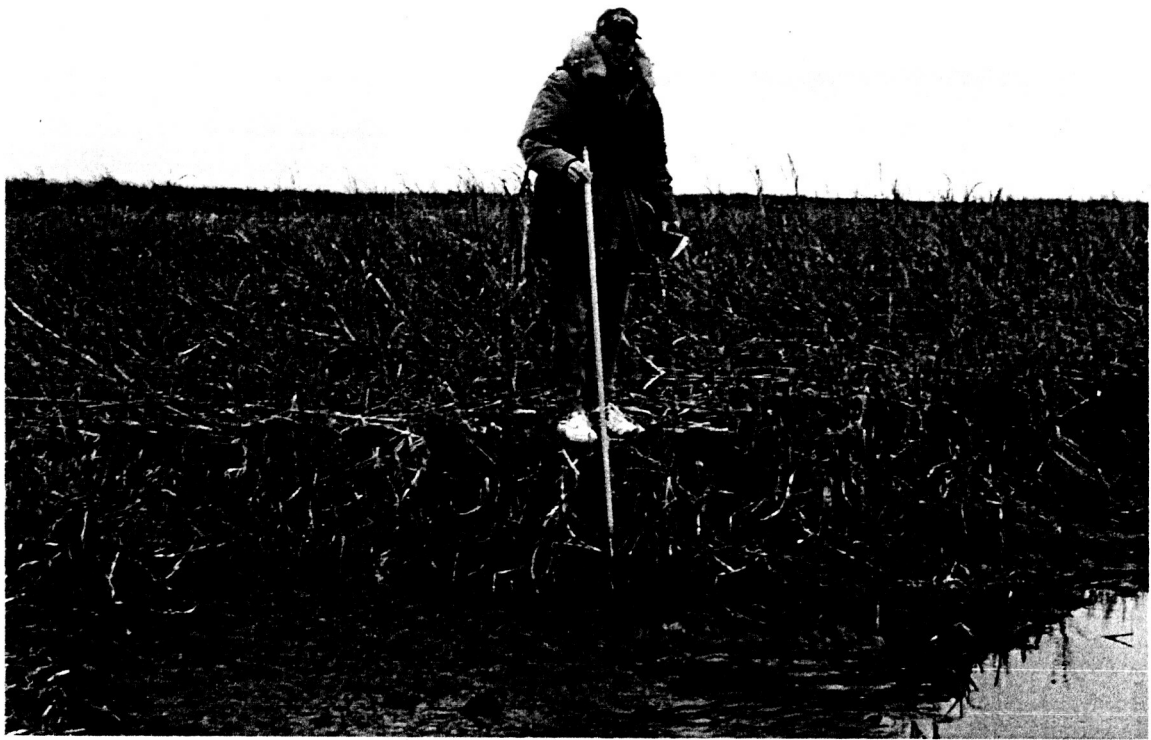
14. Mat measuring mud escarpment, about 2' high near DCS#4. The escarpment appears to be a purely erosional feature. (Dscn0145.jpg)

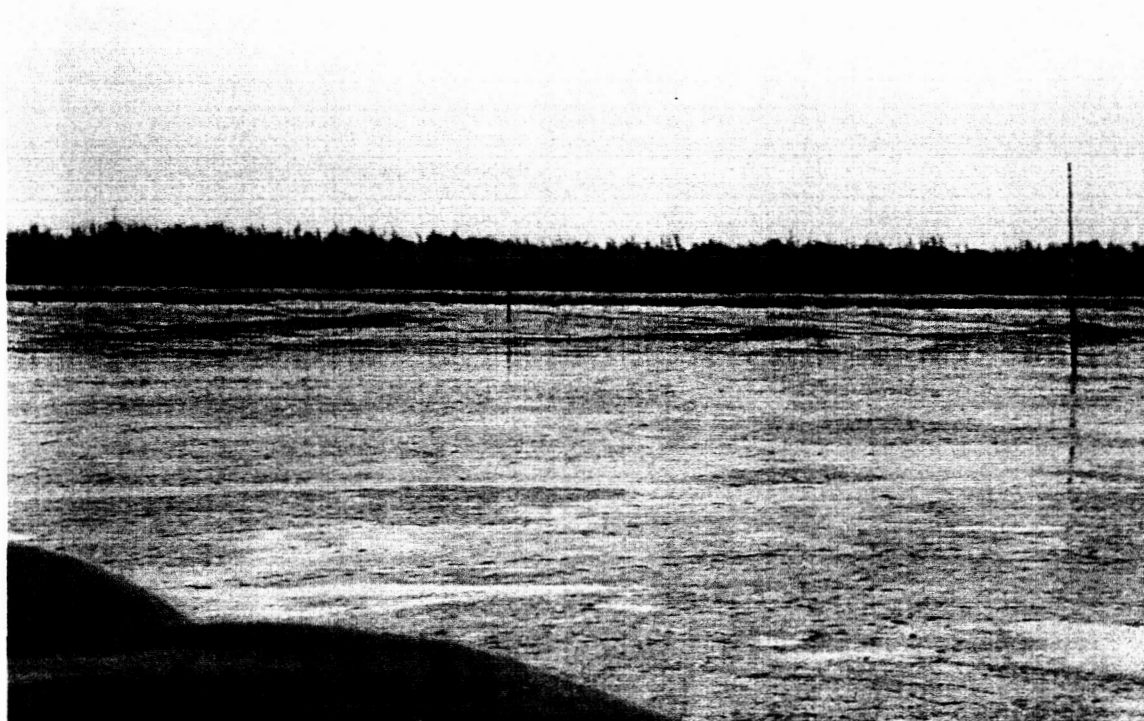
16.1 Approaching the Exxon Canal Site pipe array, ECW#2 and ECW#3 visible on fluid mud surface. (Dscn0149.jpg)

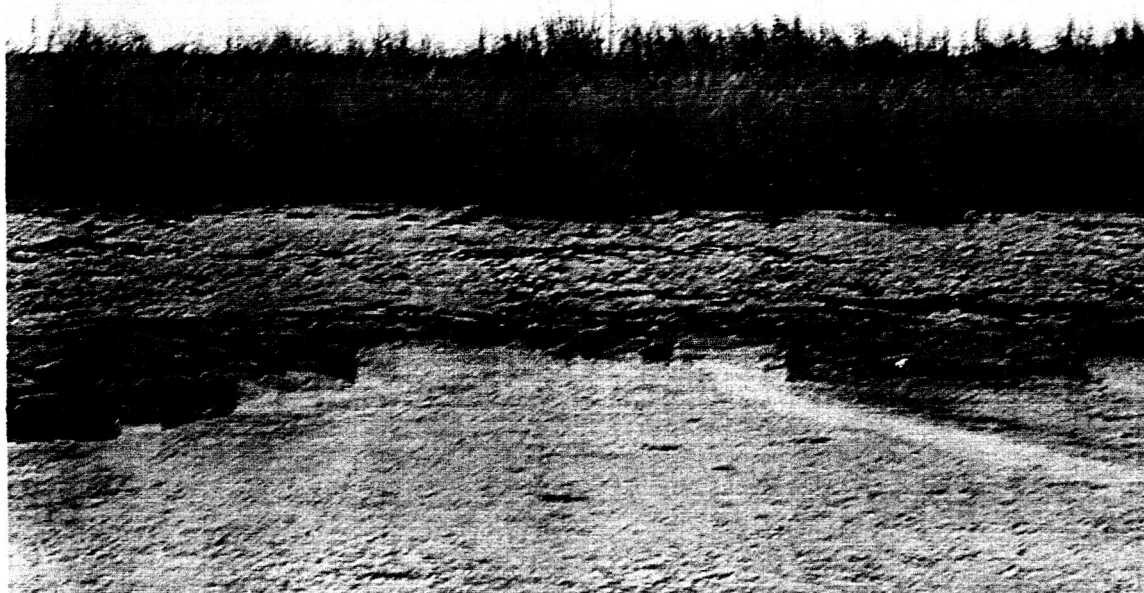
18. Shoreward from ECW#3. Note mud ridge, about 6-10" tall in foreground. ECW#4 stands about 18" tall on the mud ridge in the center of the photo about 2 meters seaward of the vegetation line. The mud ridge itself is roughly 6-8 meters front to back in the center of this photo. Note: This picture is out of focus and Paint Shop Pro was used to sharpen the image somewhat. (Dscn0153sharp.jpg)

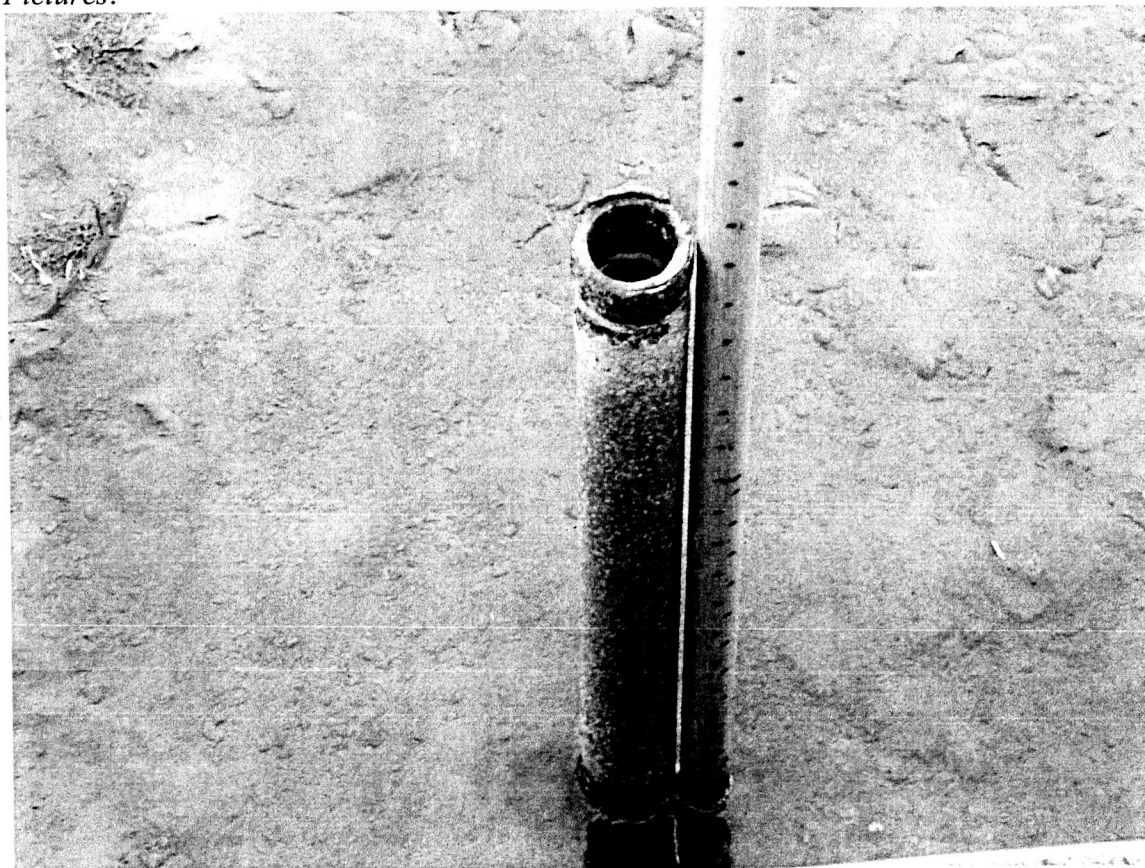
Description: We were here at about 1:30pm CST. The pipe is sheared off at a former pipe joint low to the ground (18"), probably weakened by rust. The clamp was apparently on the on the missing (upper) part of the pipe as no clamp is now visible on this pipe.

19. Measuring ECW#4. An upper section of pipe has apparently corroded and broken off, leaving the visible stem, which in this picture contains water. The clamp on this pipe is presumed to have been on the missing upper section. Henceforth, this pipe will be measured from the top of the pipe to the surface of sedimentation.
(Dscn0154.jpg)

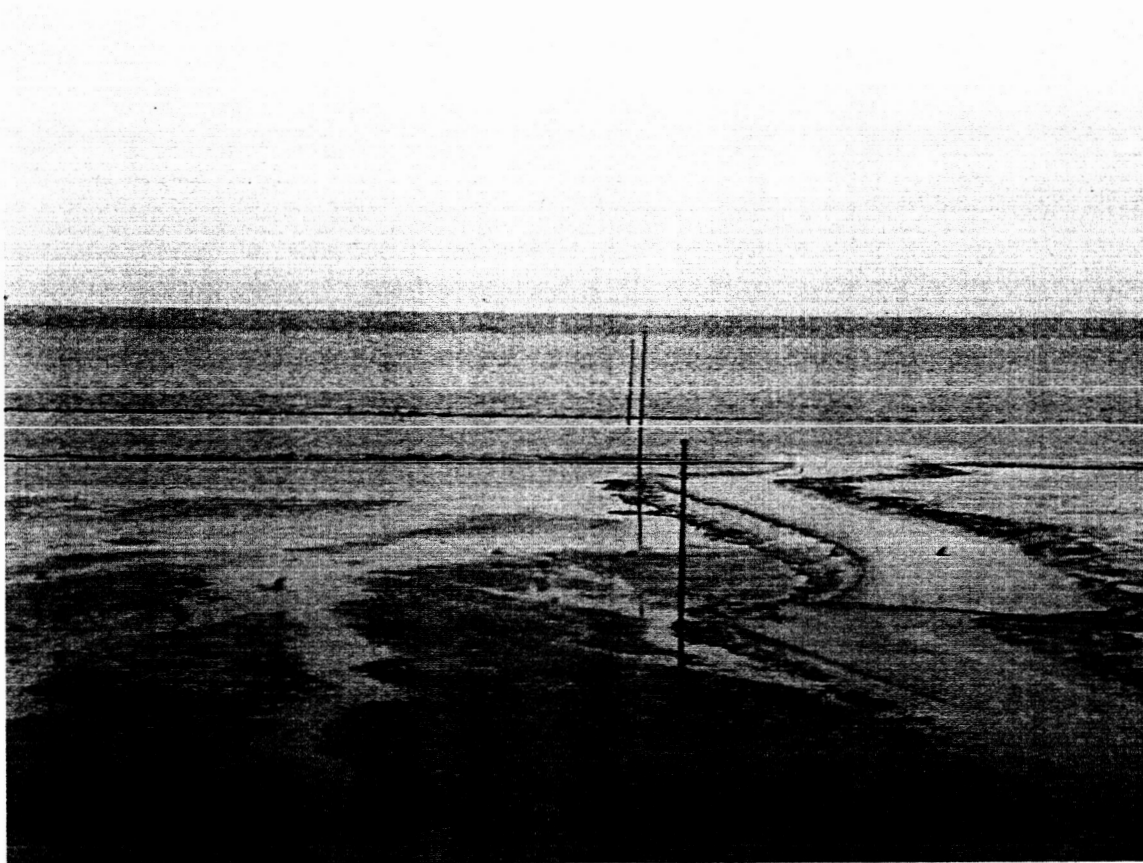
20. Seaward from ECW#4, ECW#3, ECW#2, and ECW#1 visible (fore to background). The water level has risen past ECW#1 and will continue to rise past ECW#2 (see picture 22) in the 45 minutes we spent at ECW site. Notice the tracks left in the mud by the airboat. (Dscn0155.jpg)

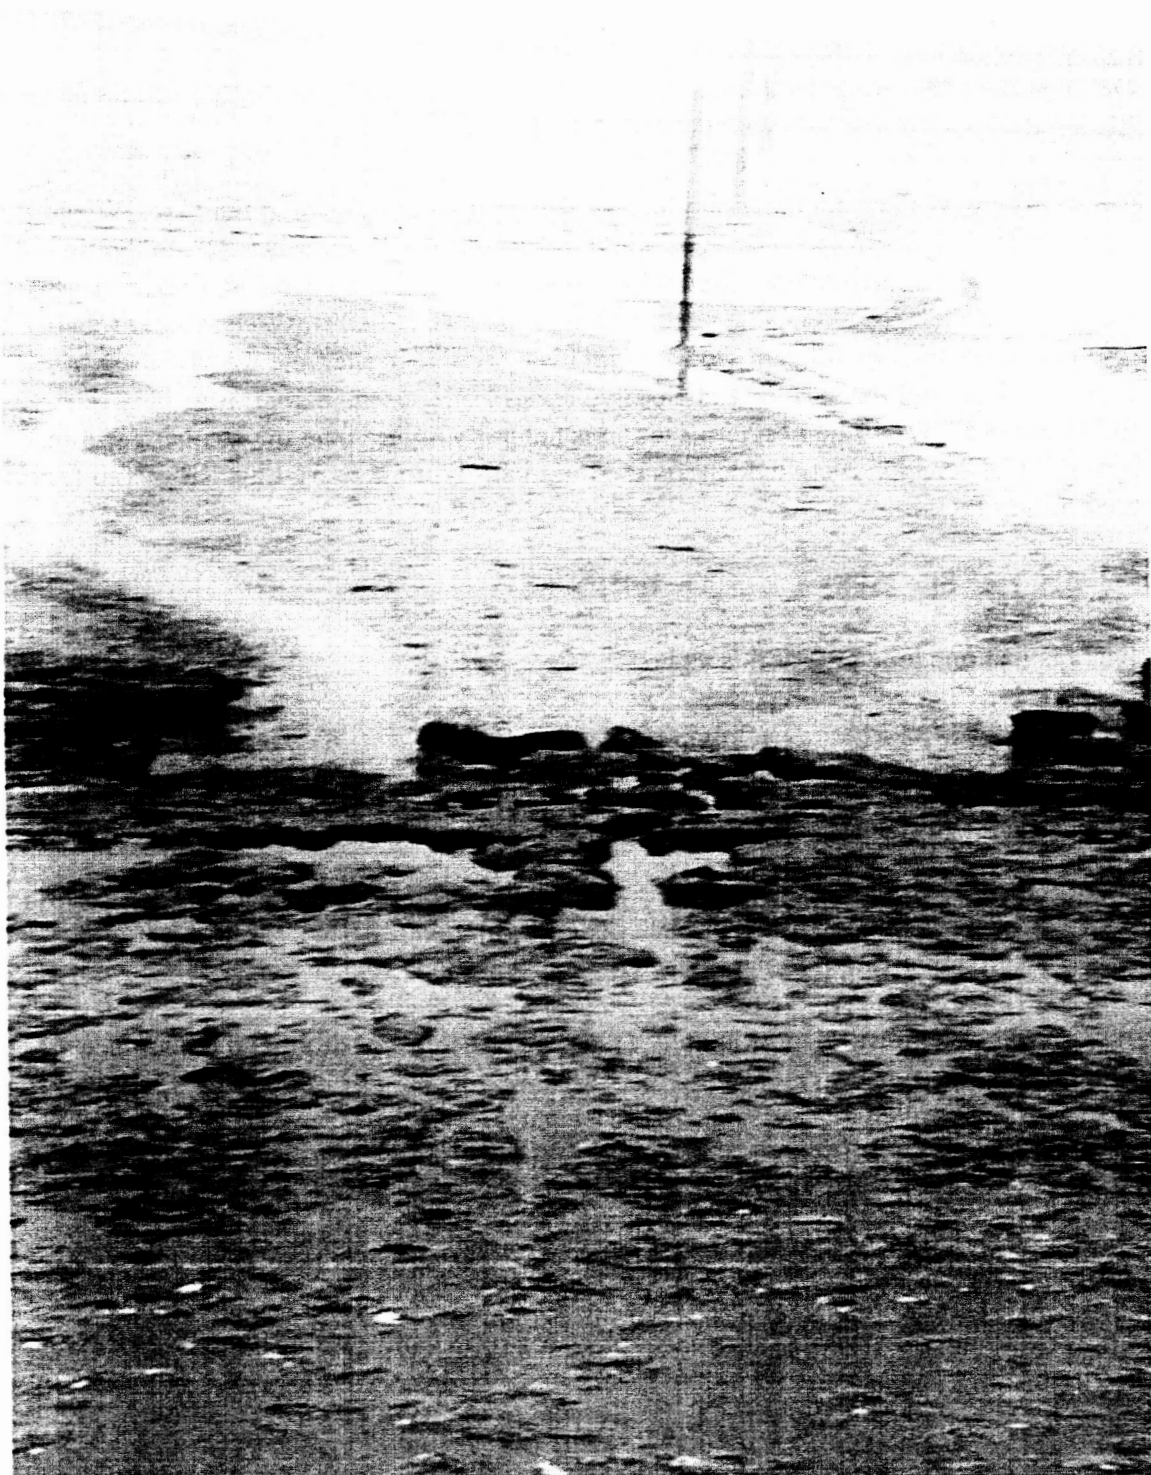
22. Mud ridge line between ECW#3 and ECW#4; picture taken from ECW#4 and ECW#3, ECW#2 and ECW#1 are visible (fore to background). Notice the left side of the image, a miniature tidal "creek" is evident. (Dscn0158.jpg)

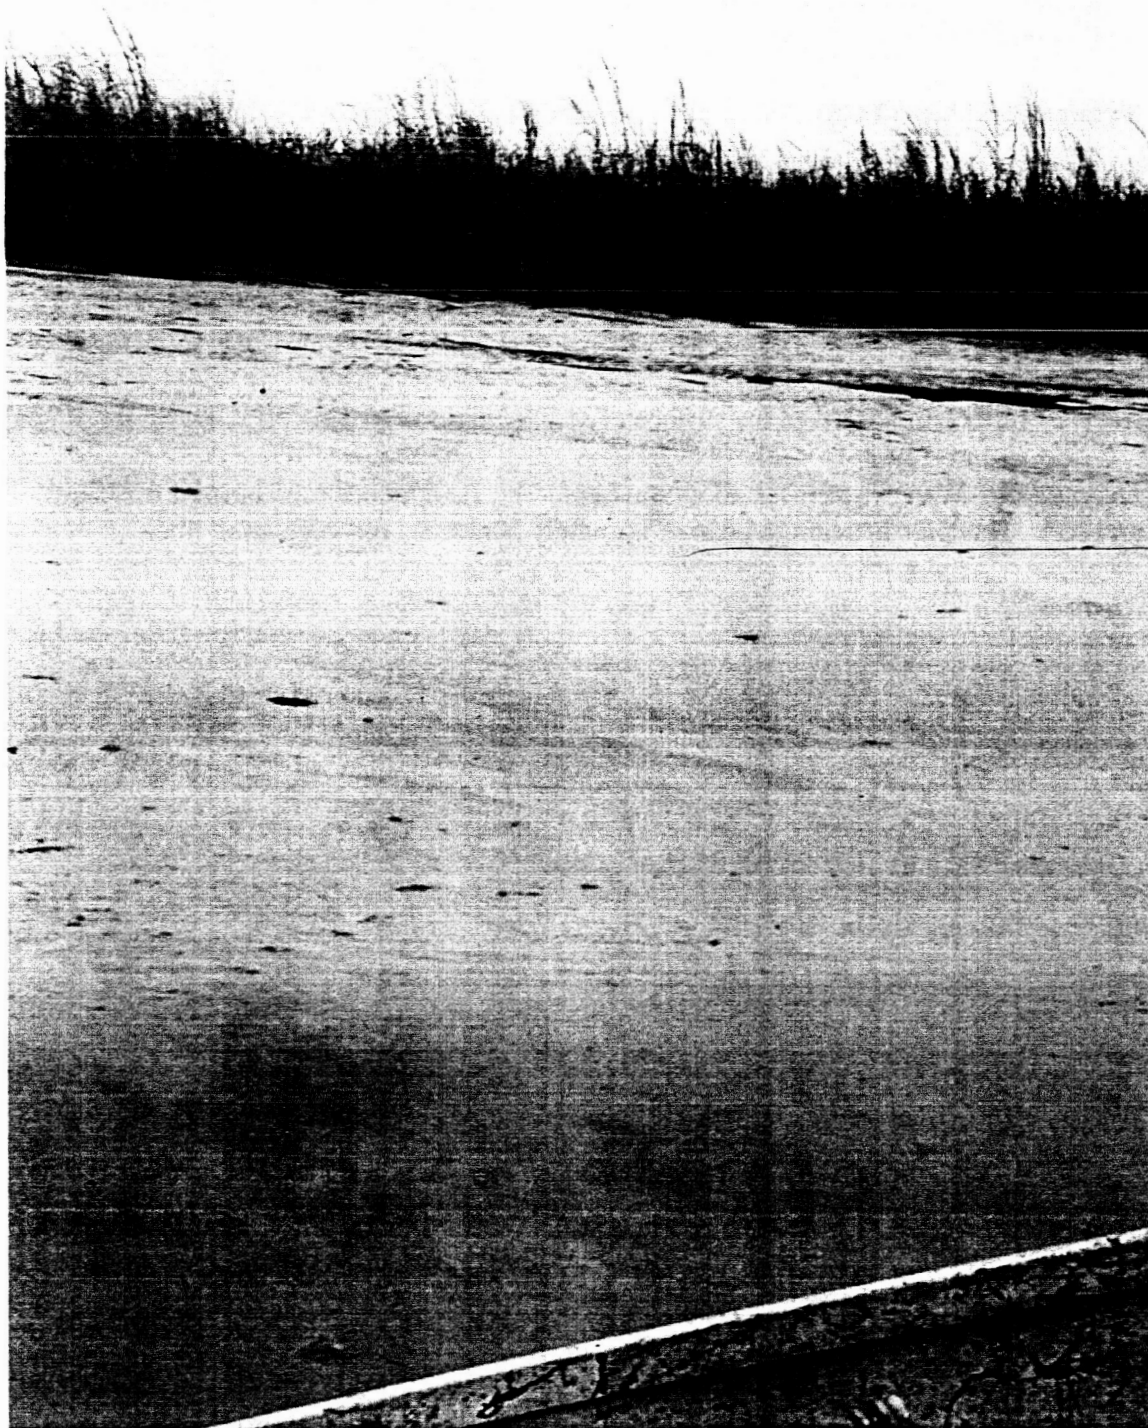
23. Shoreward from SPS#1 (solitary pipe). No mud ridge here; fluid mud flat extends up to the vegetation line. Vegetation is about 4-5 feet tall. (Dscn0159.jpg)

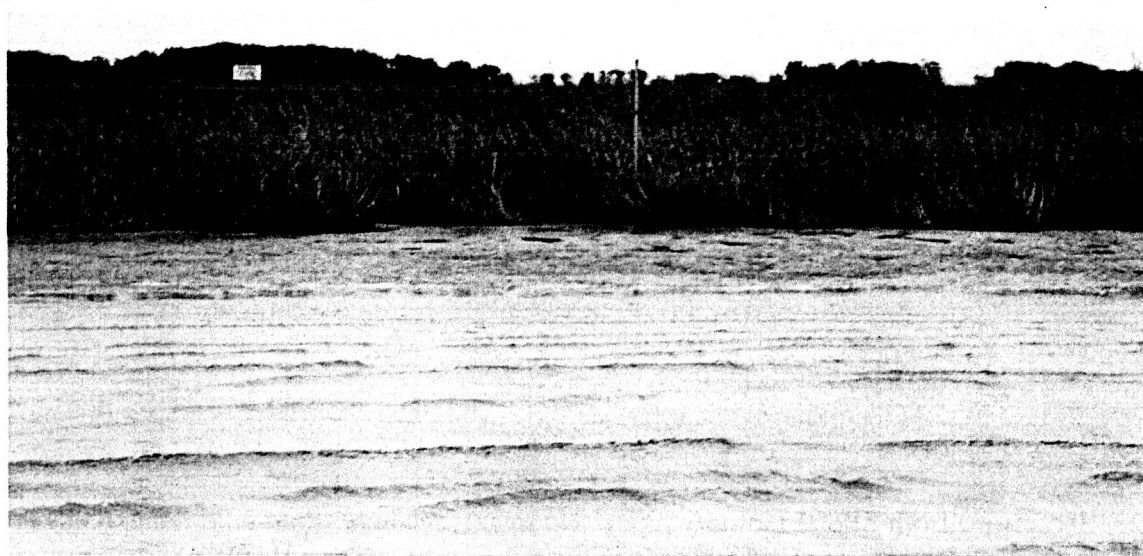
Description: Water depth was about 8in here. The subaqueous mud bottom was fluid and soft. This pipe appears to be approximately 30m from the vegetation line.

24. Shoreward from TCS#1, TCS#2 visible near the edge of vegetation. Large white advertisement billboard in left background was reputed to be near shoreline when installed years ago. (Dscn0160.jpg)
